**CONSENT ORDER
ISSUED UNDER THE
WATER POLLUTION CONTROL ACT
WEST VIRGINIA CODE, CHAPTER 22, ARTICLE 11**

TO: Mountain Valley Pipeline, LLC
Attn: Robert J. Cooper
Senior Vice President, Engineering and Construction
625 Liberty Ave, Ste 1700
Pittsburgh, PA 15222

DATE: April 19, 2019

ORDER NO.: 8951

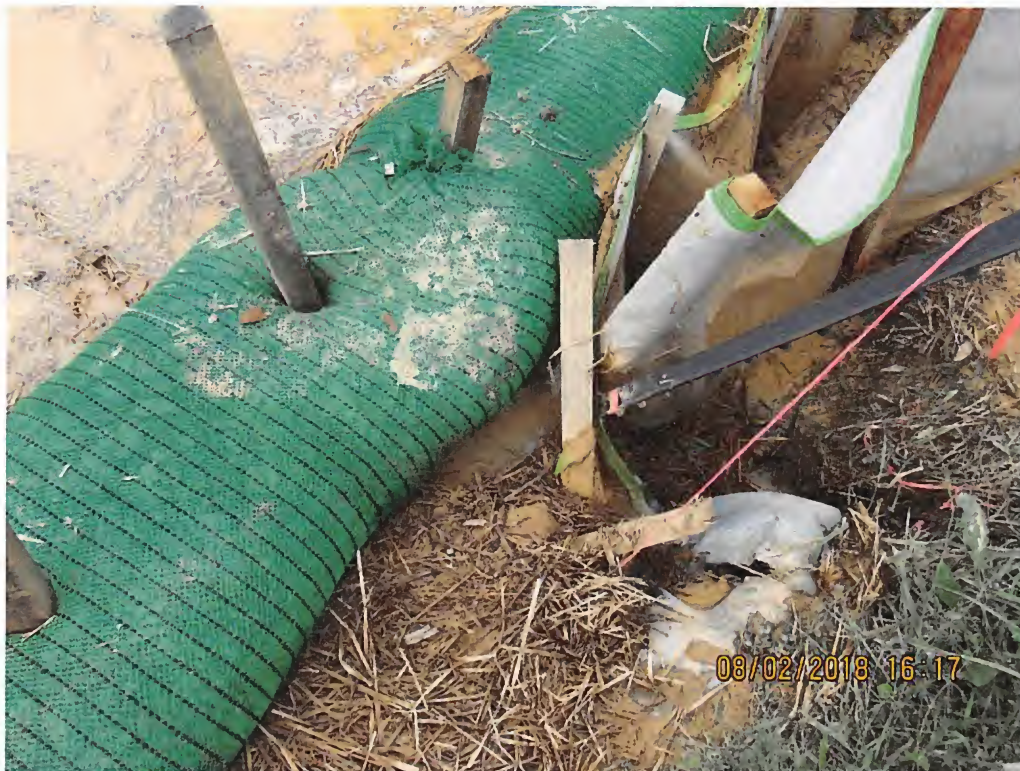
Sediment laden water entering culvert.

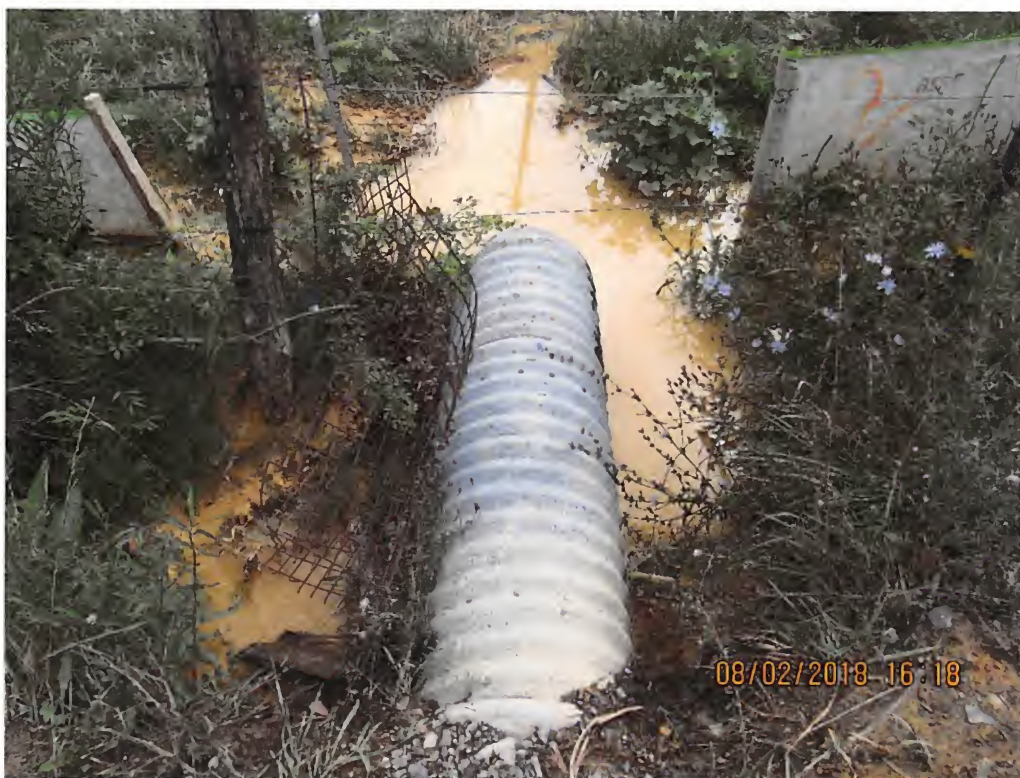
Culvert outlet into wetland area across road from full sump.

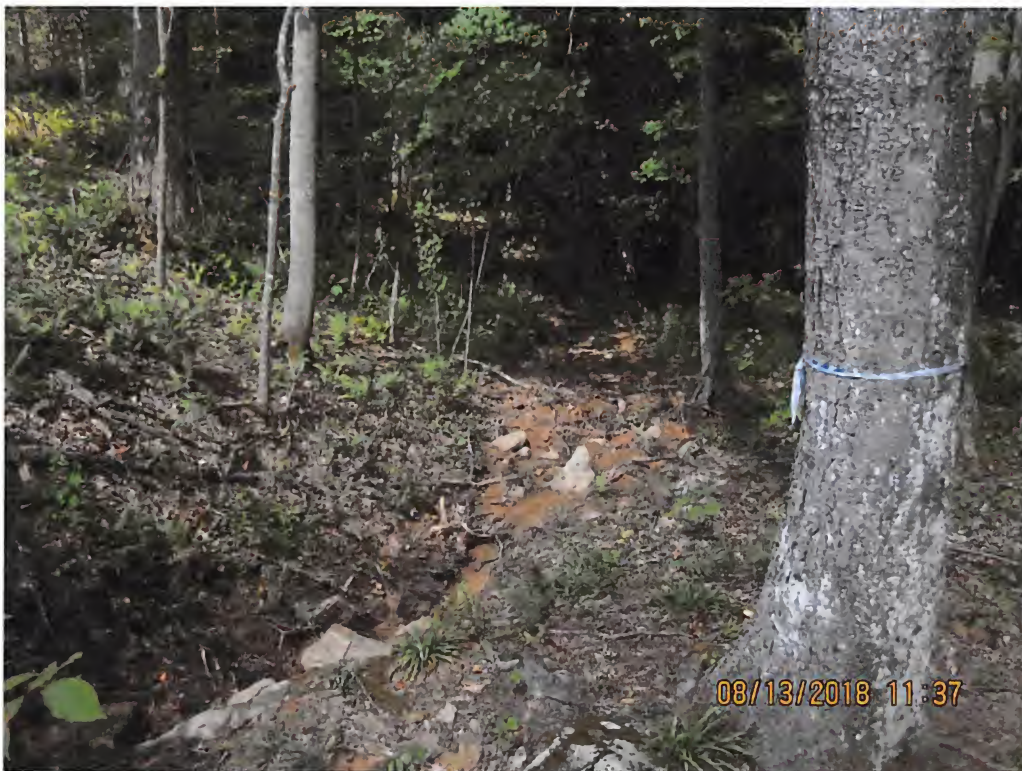
At St. 00+220 a series of perimeter controls used in a concentrated flow area had failed allowing sediment laden water to leave the site. Sediment deposits were noted in receiving stream A-104 creating Conditions Not Allowable in the Waters of the State.

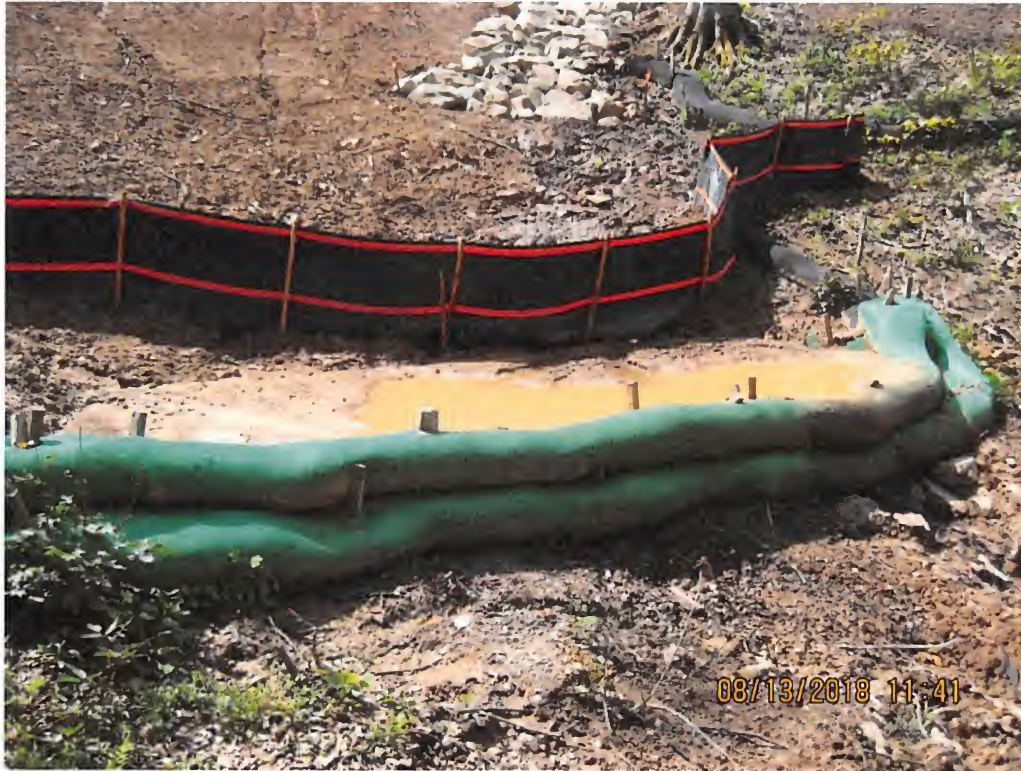
Maintenance needed north of the east wall.

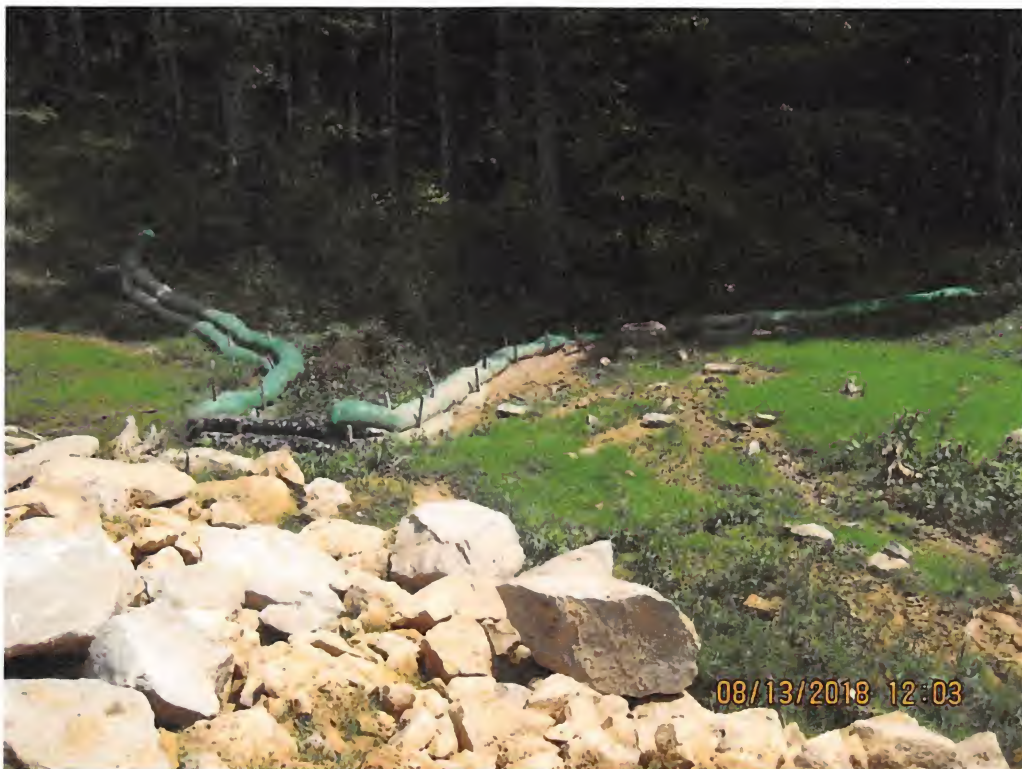
Maintenance needed for CFS below the east wall.

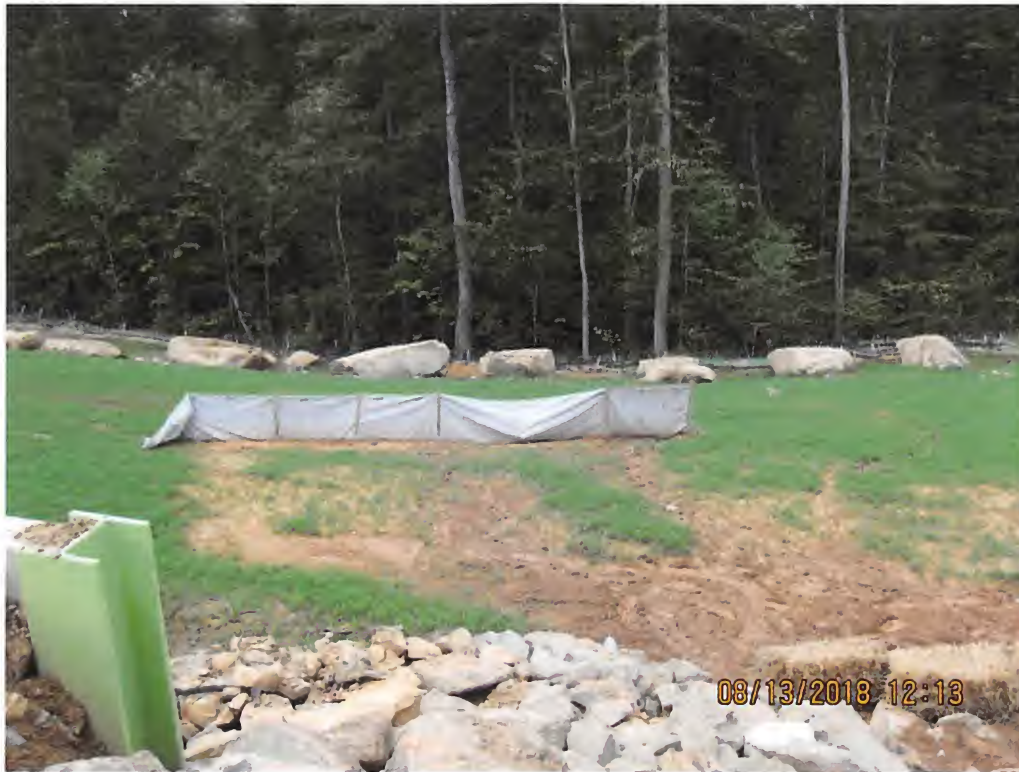
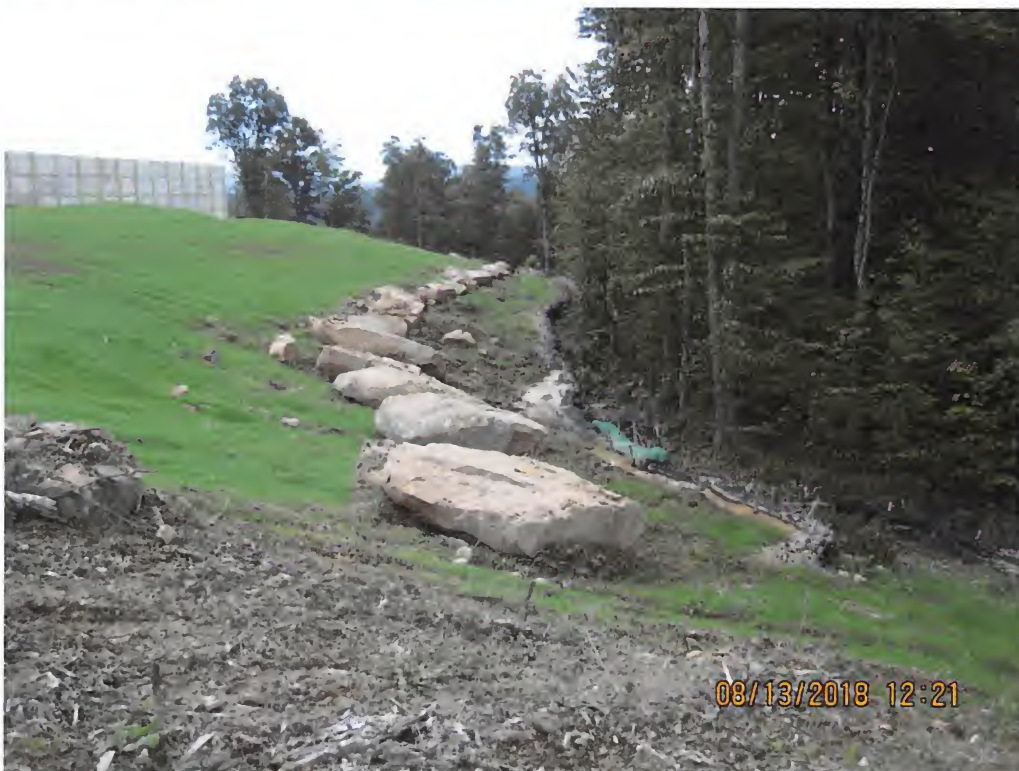
Maintenance needed for filter sock at Southwest wall.

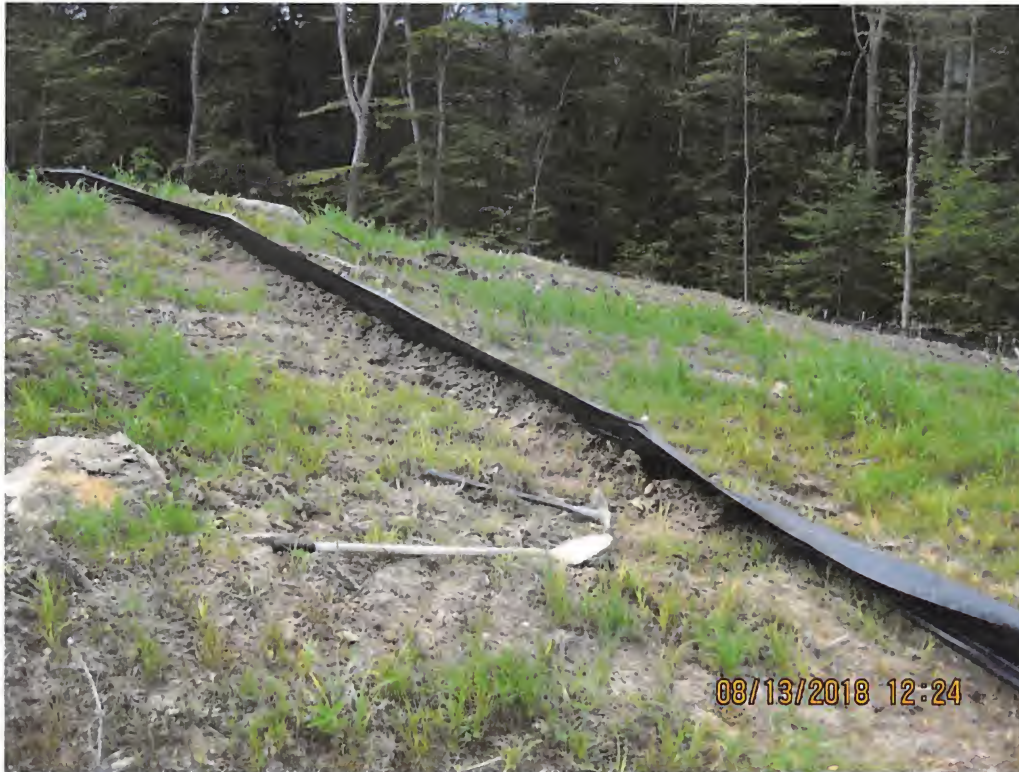
Silt fence being installed on the southern portion of the pad area was not joined or trenched in properly.

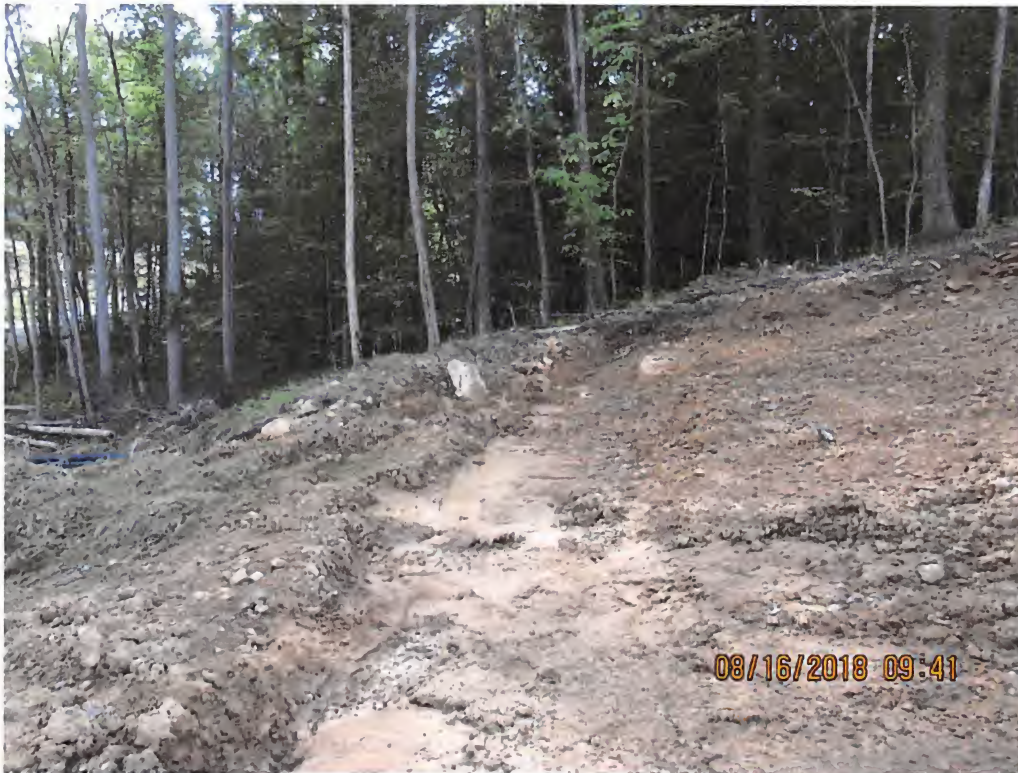
Photo 1: Eastern view of one of several incorrectly sloped water bars off Bingham Road station 7450+00.

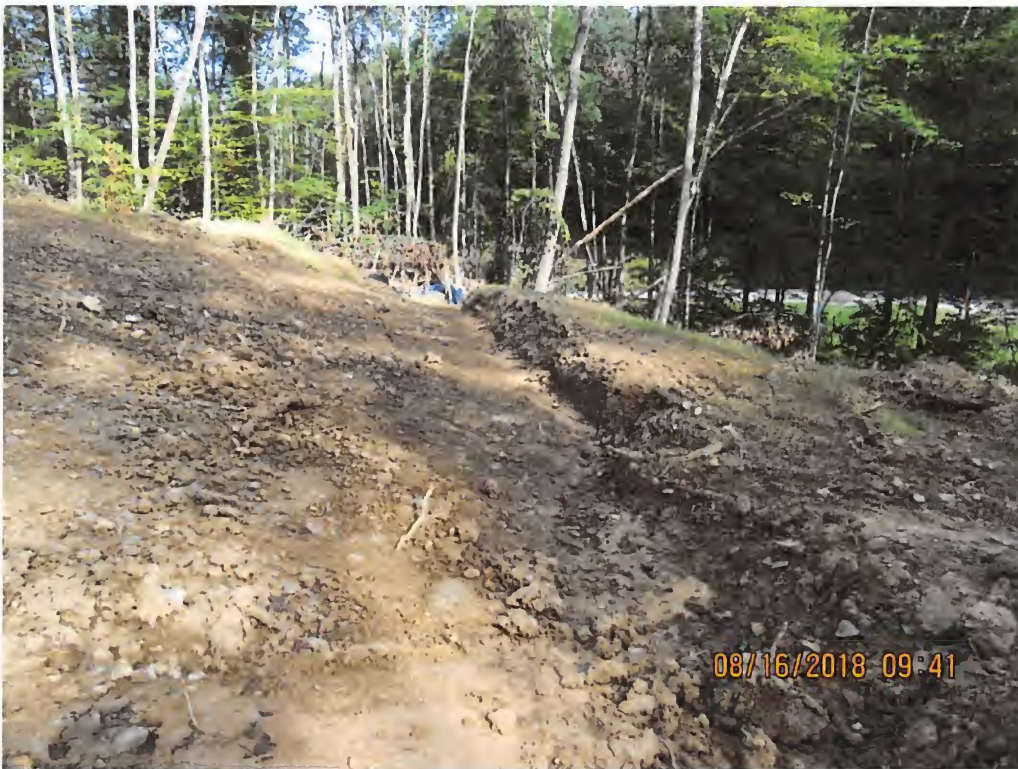
Photo 2: Western view of one of several incorrectly sloped water bars in Photo 1 off Bingham Road station 7450+00.

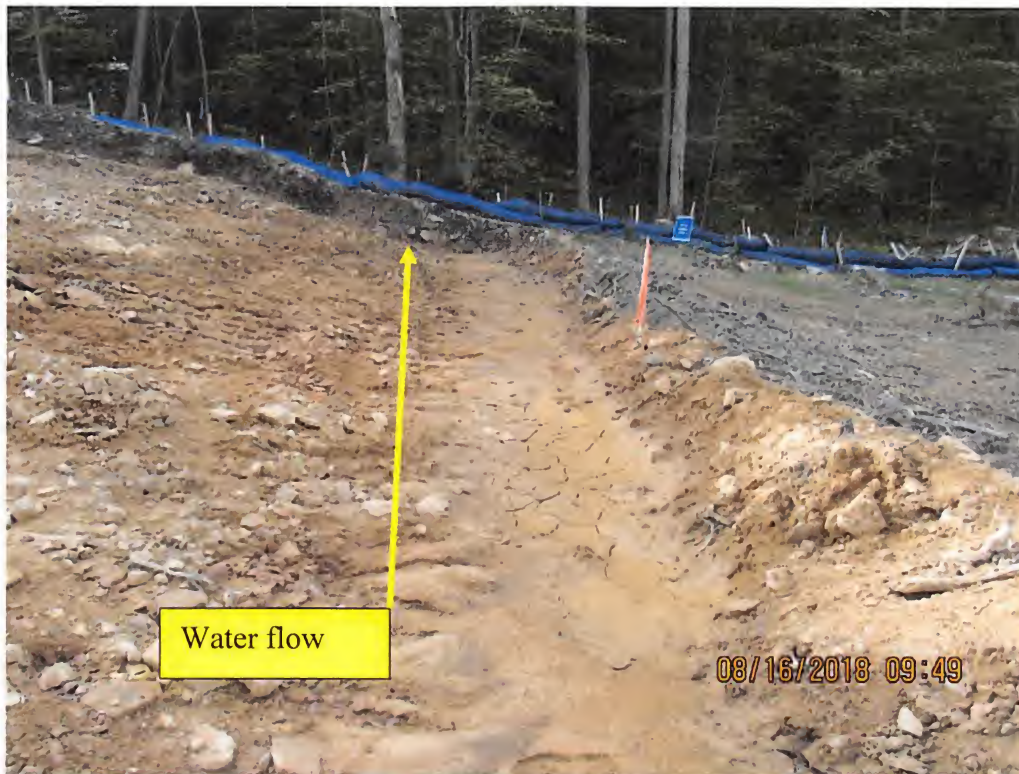
Photo 3: Incorrectly sloped water bar at Bingham Road station 7450+00- water is flowing away from outlet.

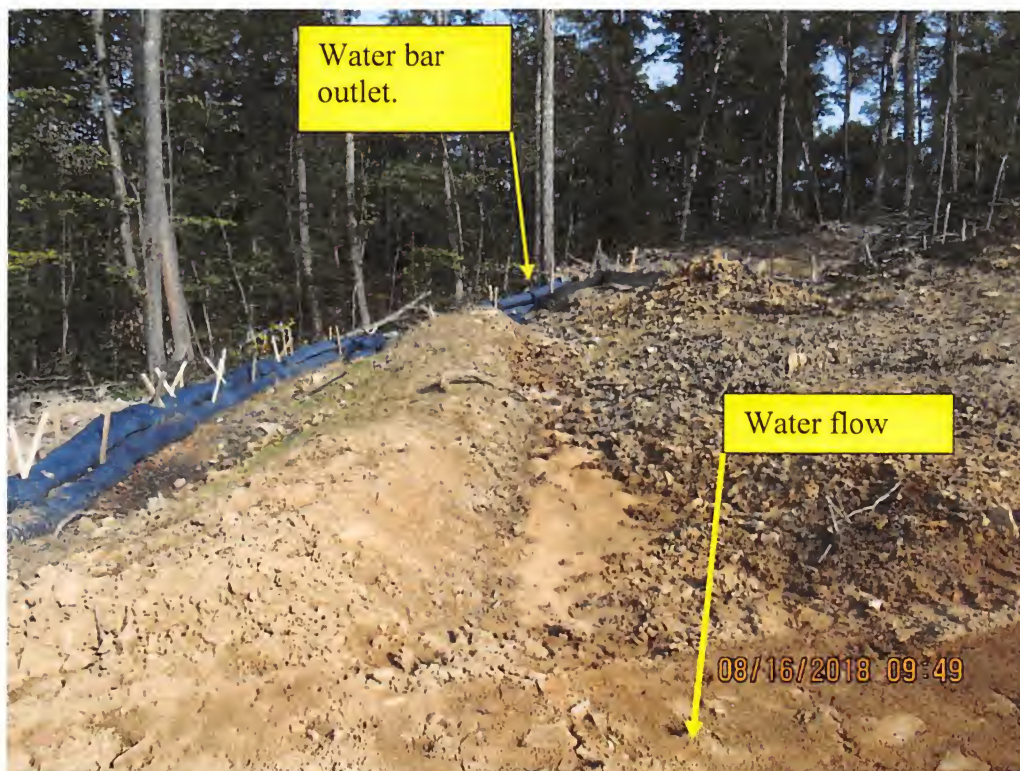
Photo 4: Outlet for water bar in Photo 3.

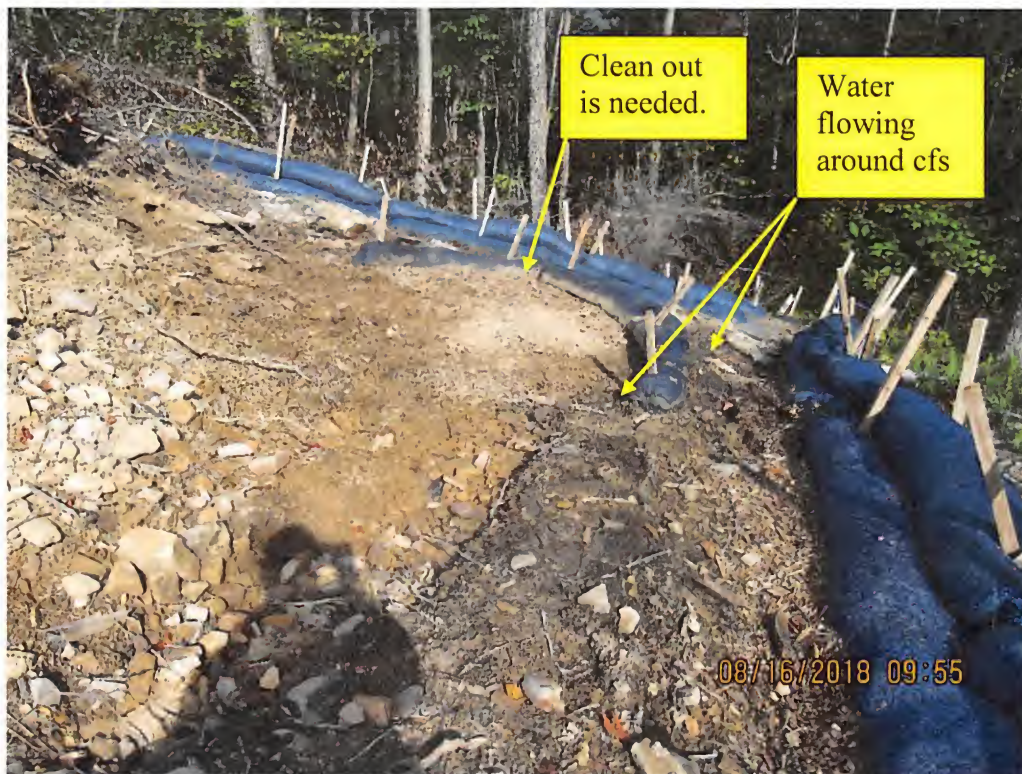
Photo 5: Water bar terminus needs maintenance at Bingham Road station 7450+00.

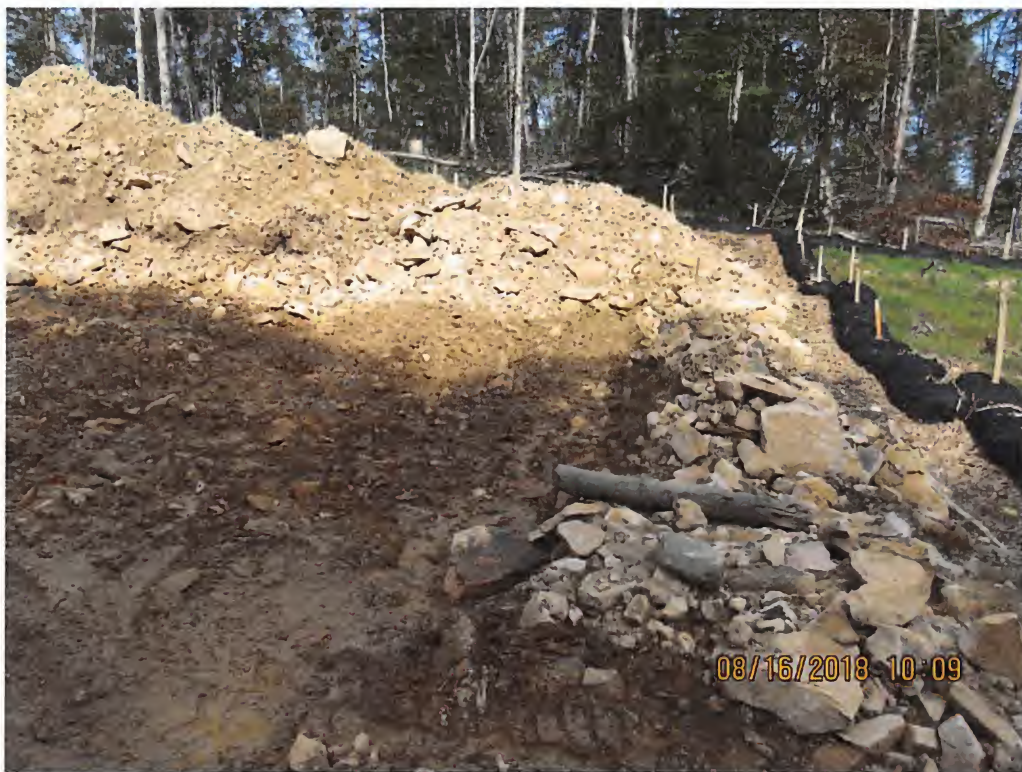
Photo 6: Western view of water bar without outlet near Bingham Road station 7450+00.

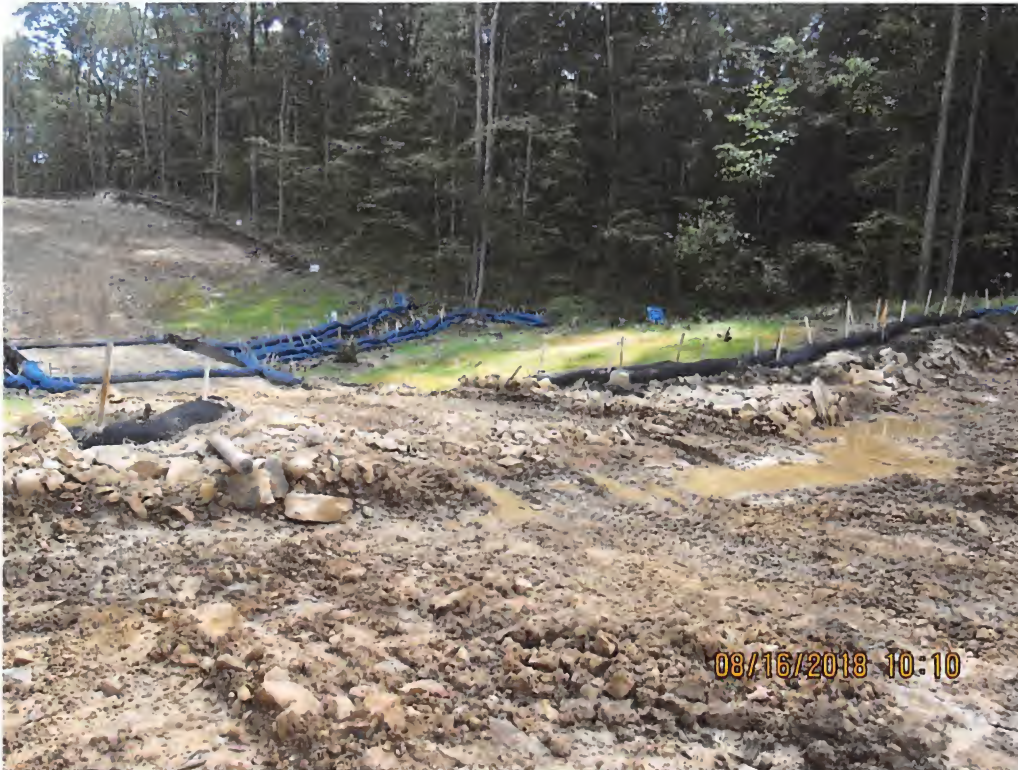
Photo 7: Middle section of water bar without outlet near Bingham Road station 7450+00.

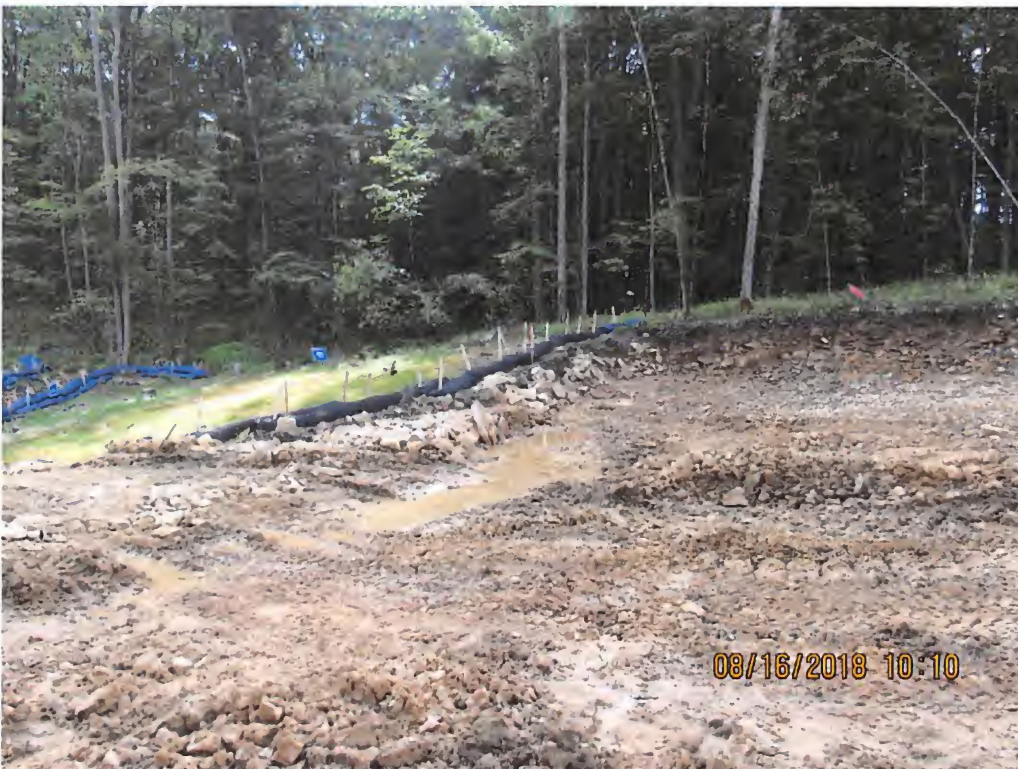
Photo 8: Eastern view of water bar without outlet near Bingham Road.

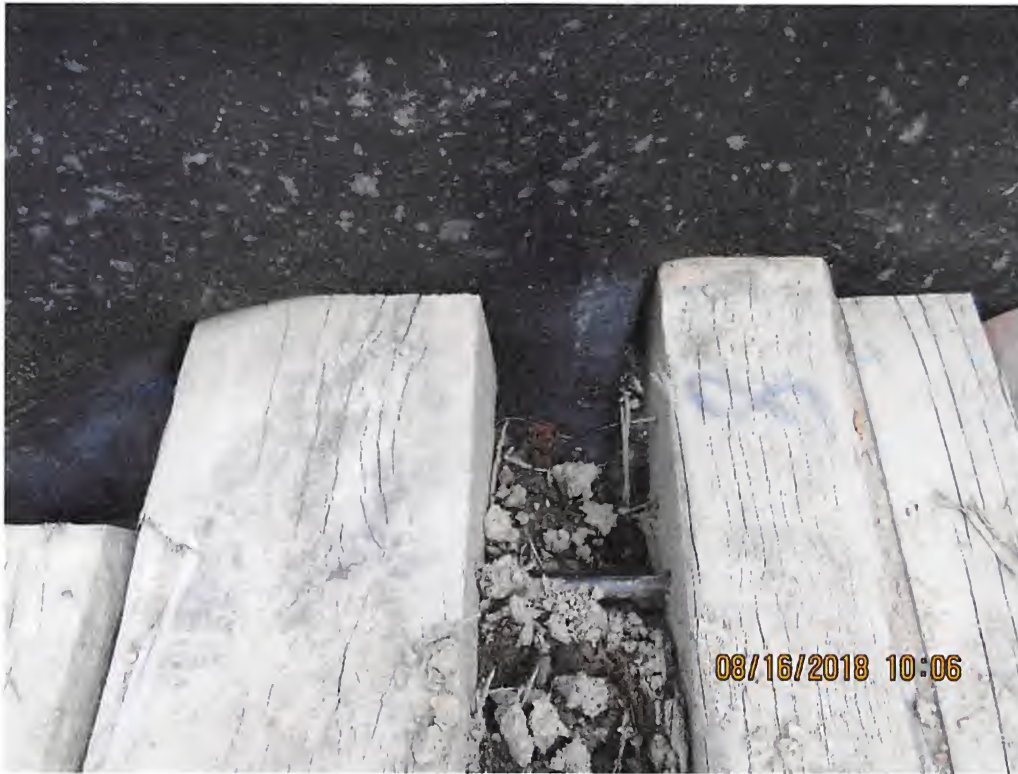
Photo 9: Timber bridge mat punctured filter fabric at station 7465+00.

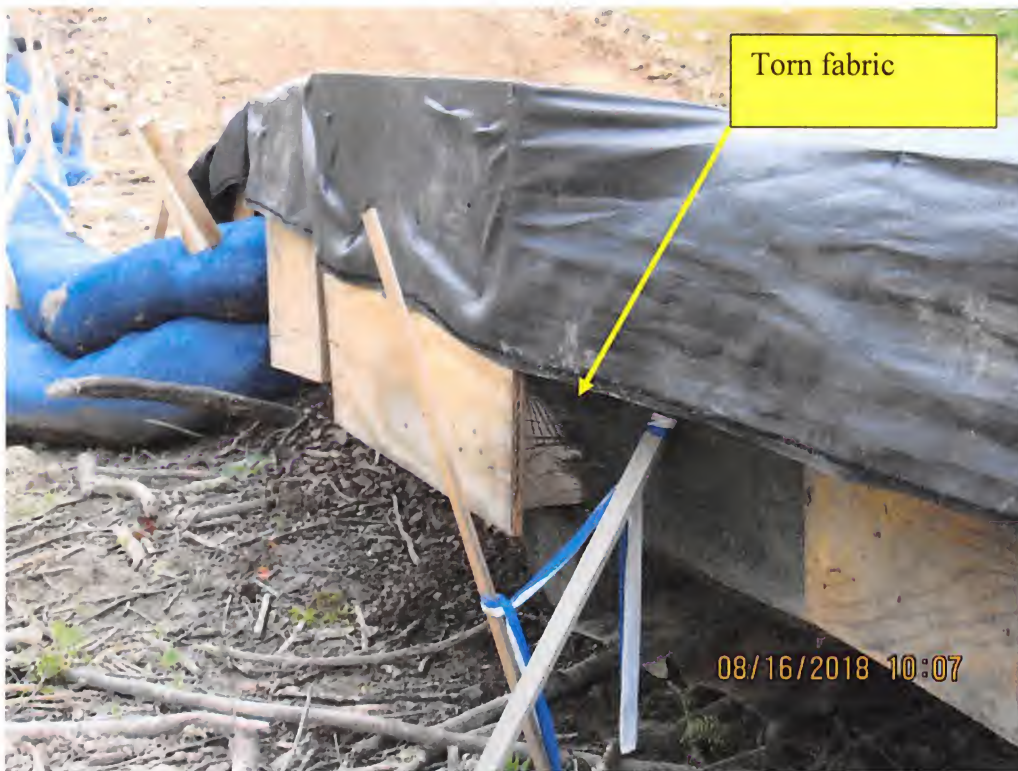
Photo 10: Exterior view of punctured fabric in Photo 9.

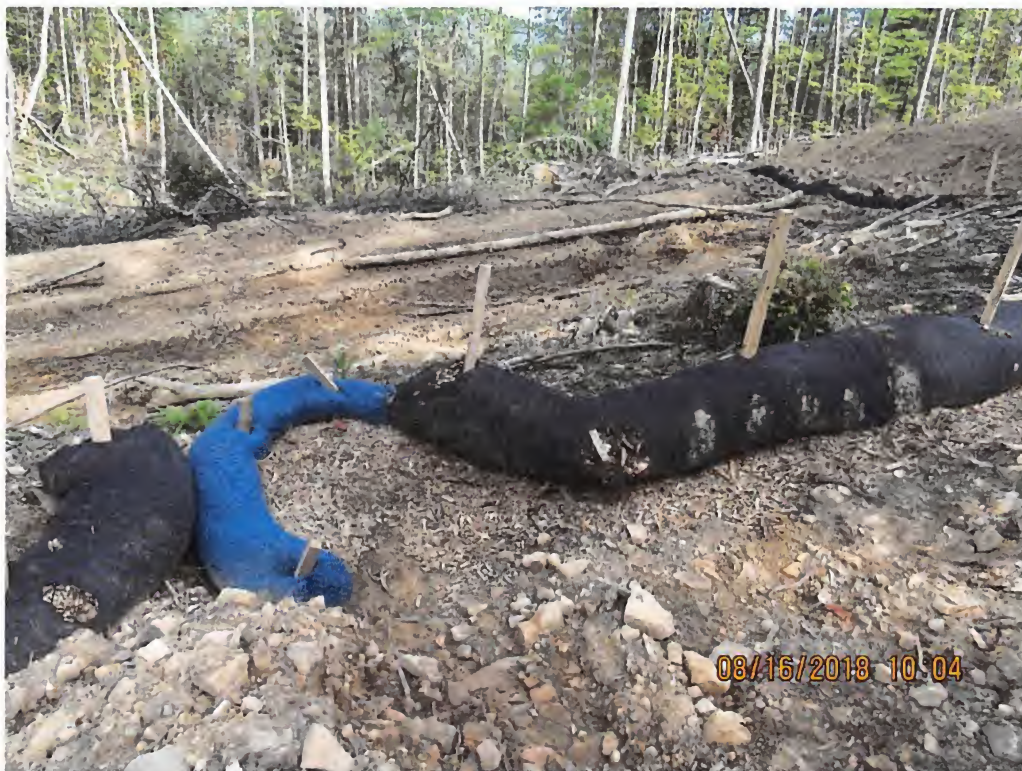
Photo 12: CFS needs maintenance near Bingham Road station 7450+00.

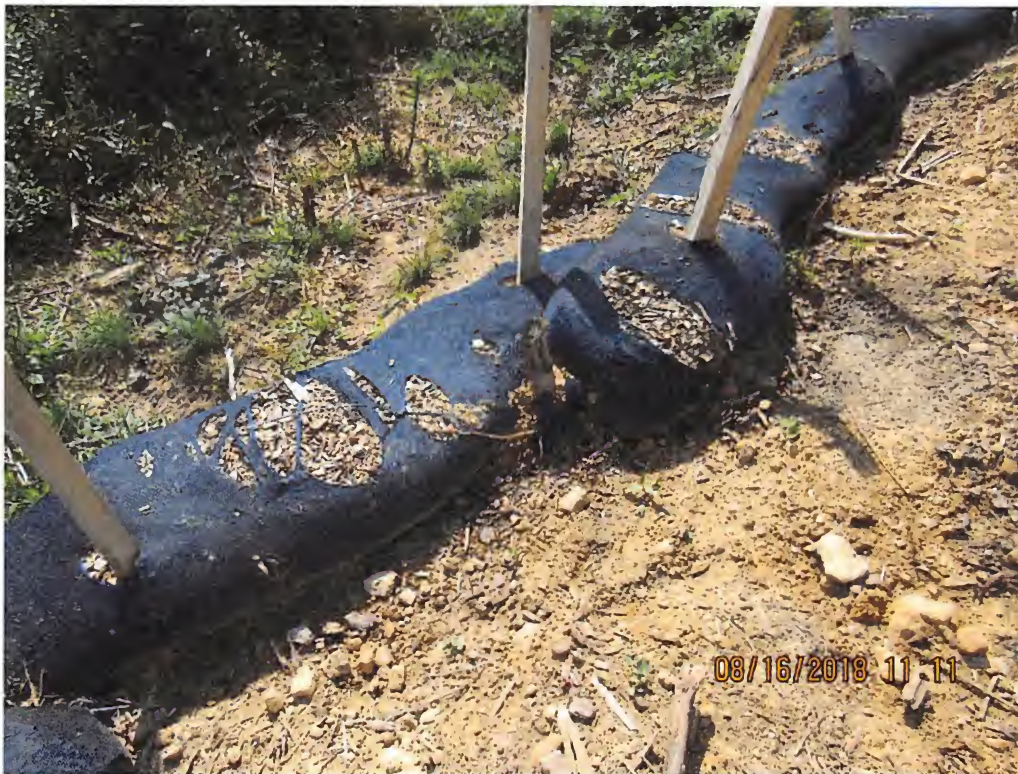
Photo 13: CFS needs maintenance near station 7232+00

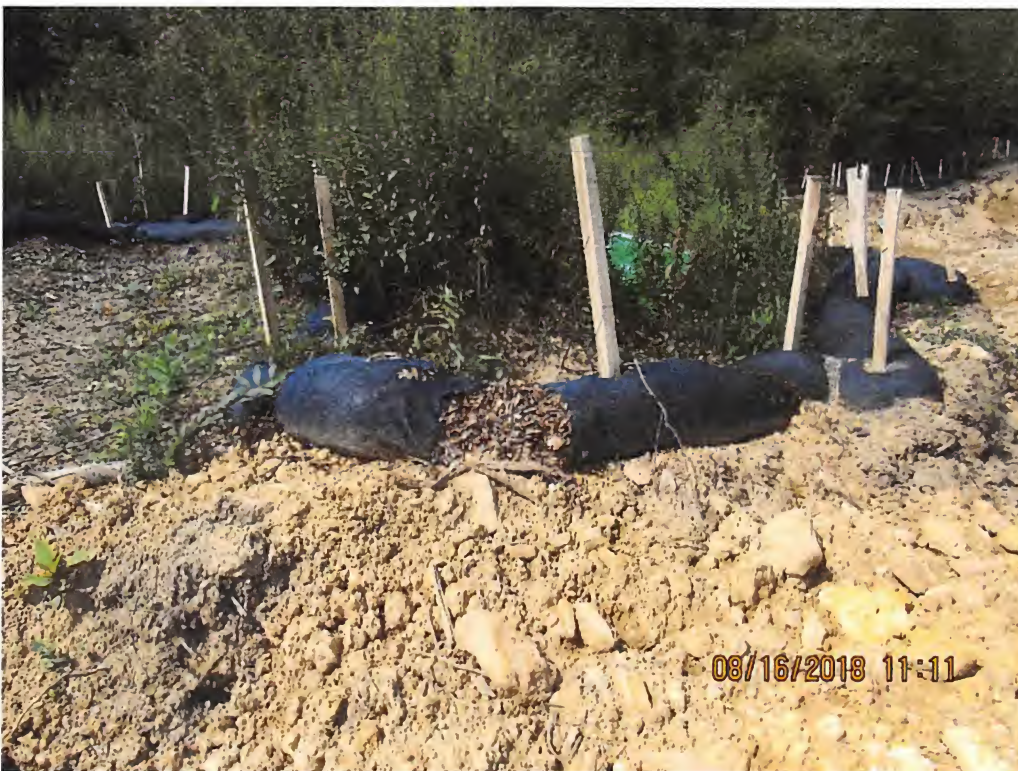
Photo 14: CFS needs maintenance near station 73232+00.

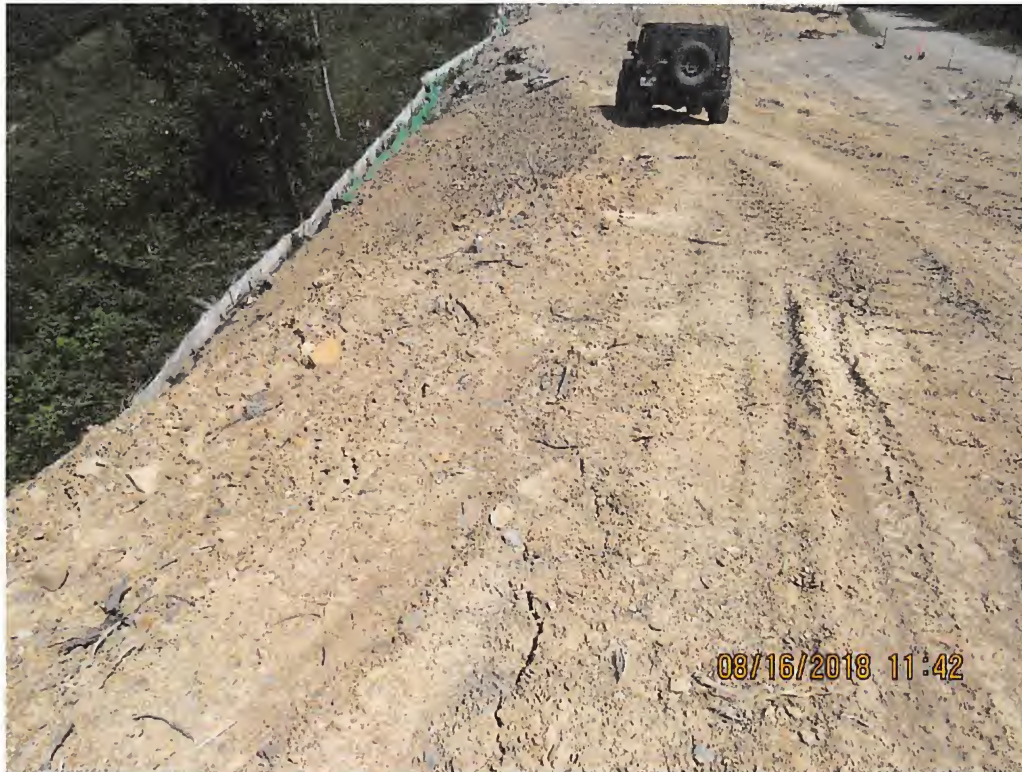
Photo 15: Northern view of Bamboo Road near Station 7158+00 without fill slope protection and temporary stabilization.

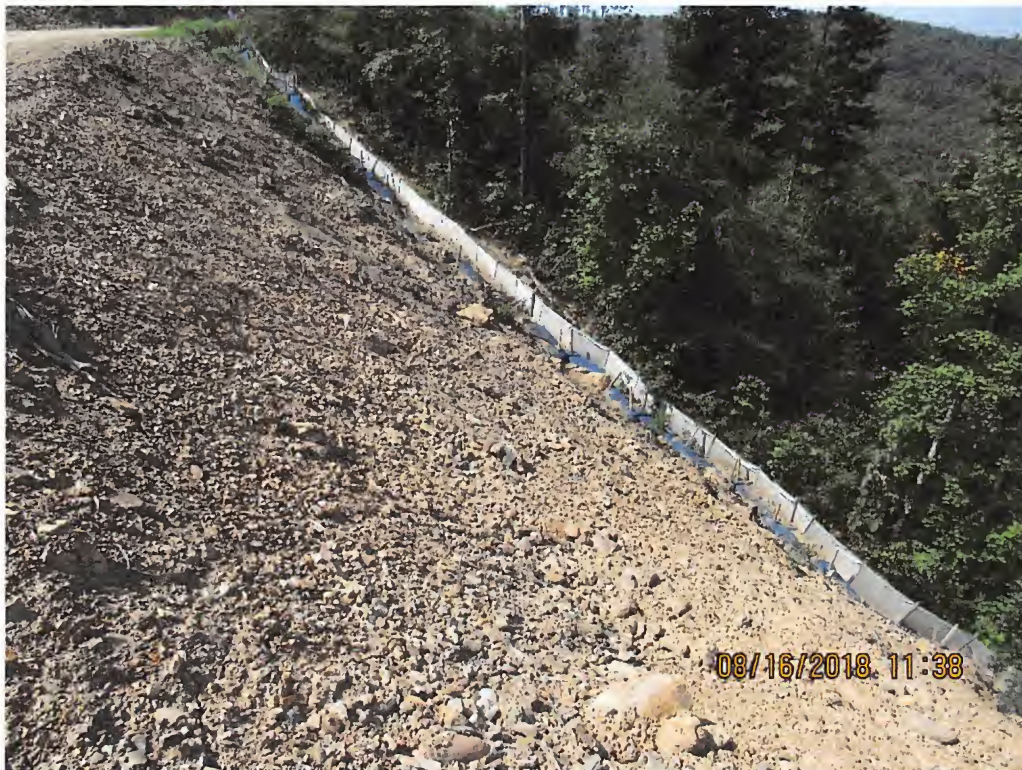
Photo 16: Southern view of Bamboo Road near Station 7158+00 without fill slope protection and temporary stabilization.

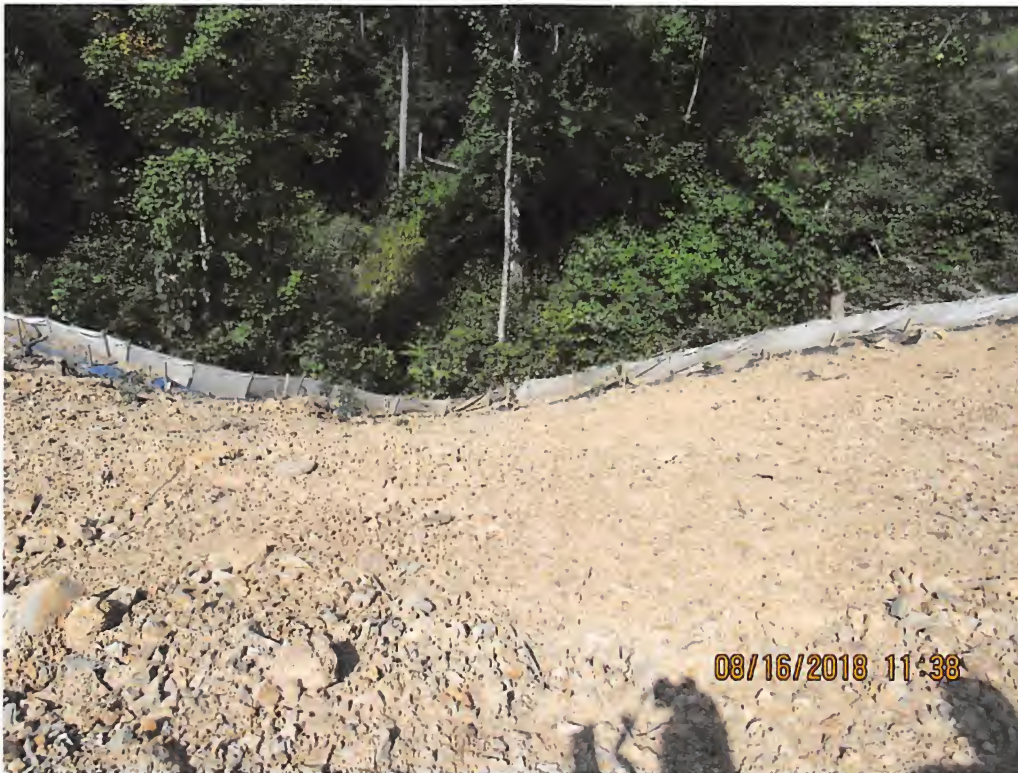
Photo 17: Inadequate controls for concentrated flow at base of fill slope near station 7158+00.

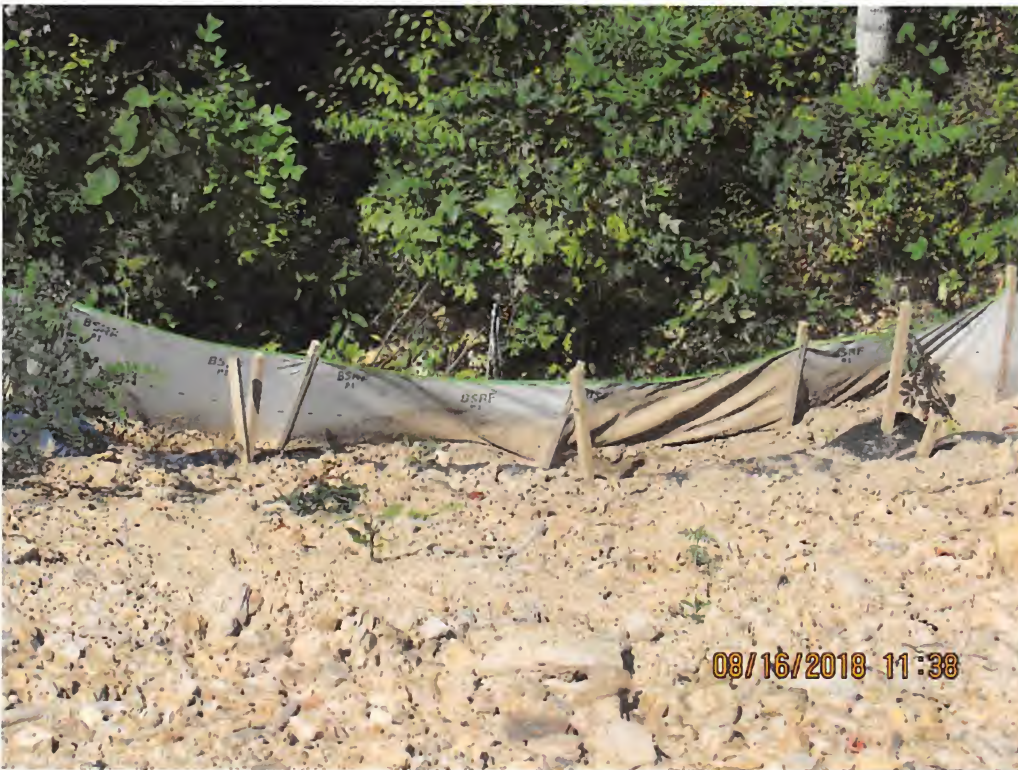
Photo 18: Close-up of inadequate controls for concentrated flow at base of fill slope near station 7158+00.

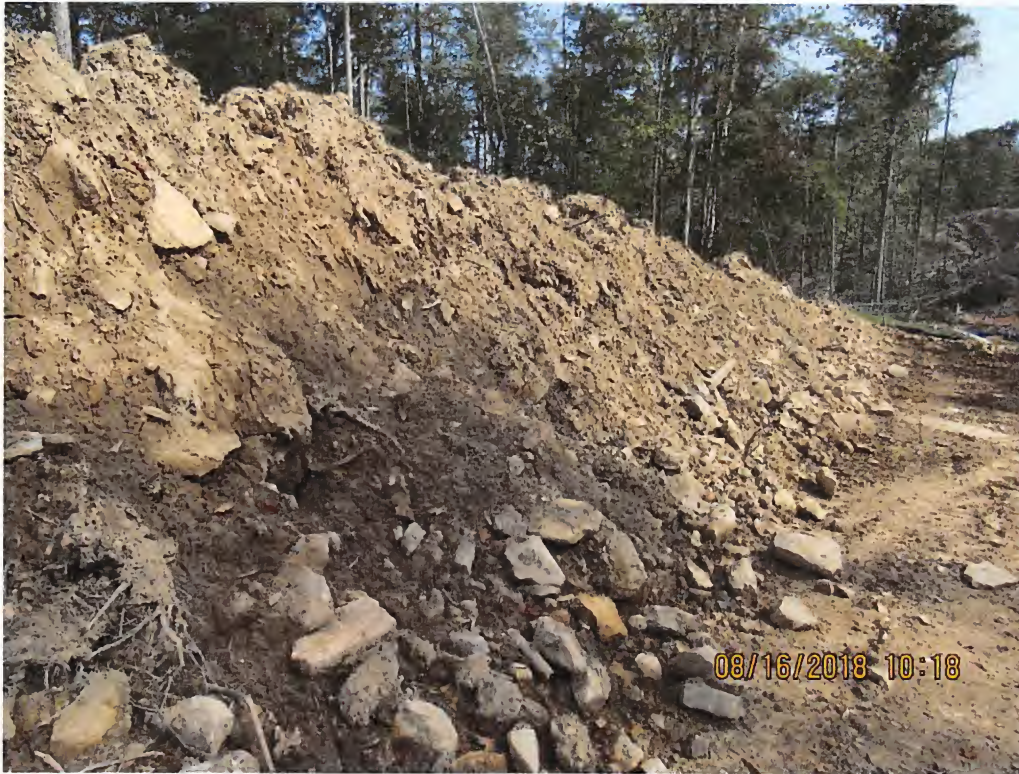
Photo 19: Northern view of waste pile with inadequate stabilization. (Photo taken near Bingham Road station 7450+00)

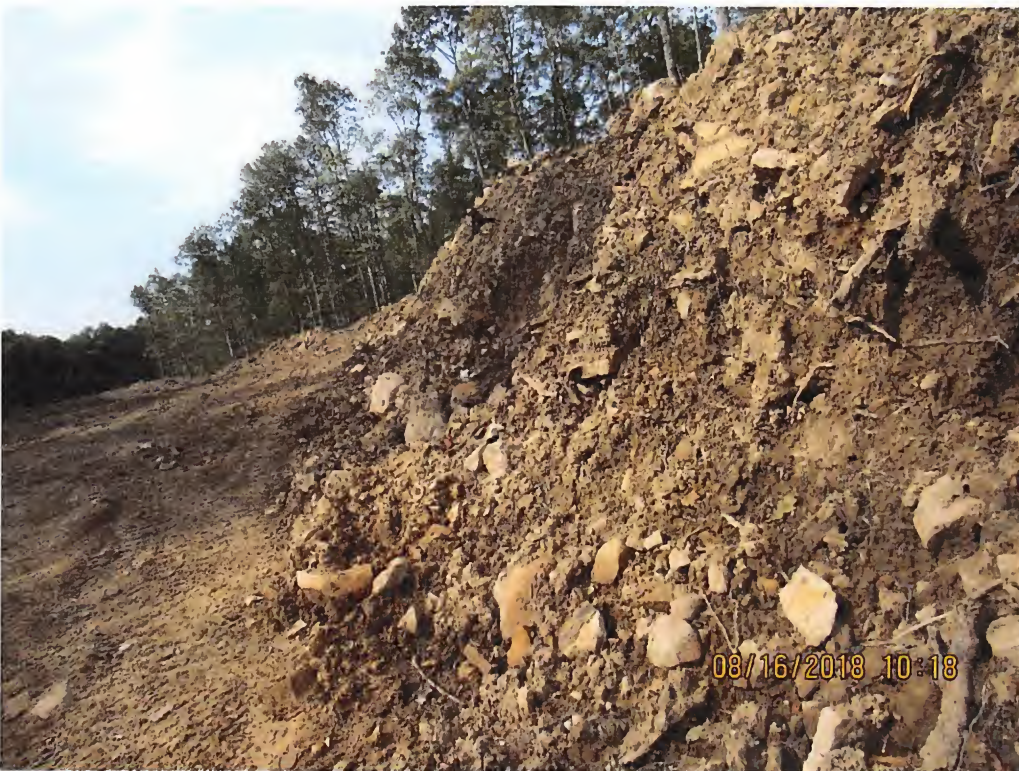
Photo 20: Southern view of waste pile with inadequate stabilization. (Photo taken near Bingham Road station 7450+00)

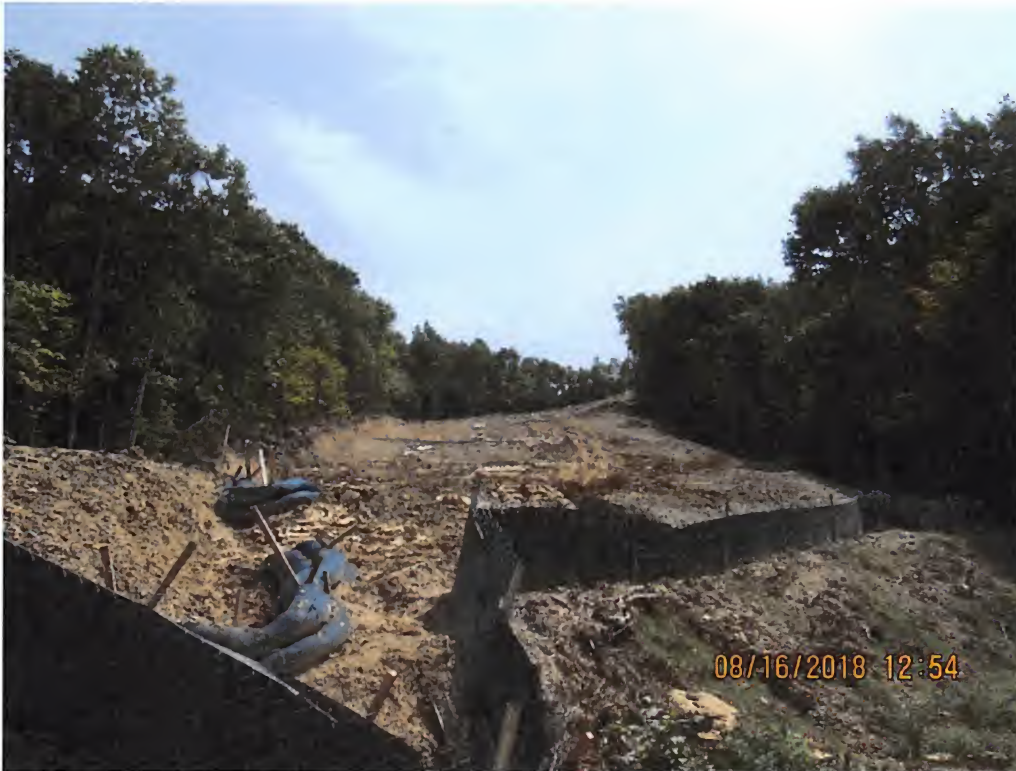
Photo 21: ROW slope between stations 7084+00- 7093+50 with inadequate number of water bars.
